STRAW BALE HOUSE MOISTURE RESEARCH

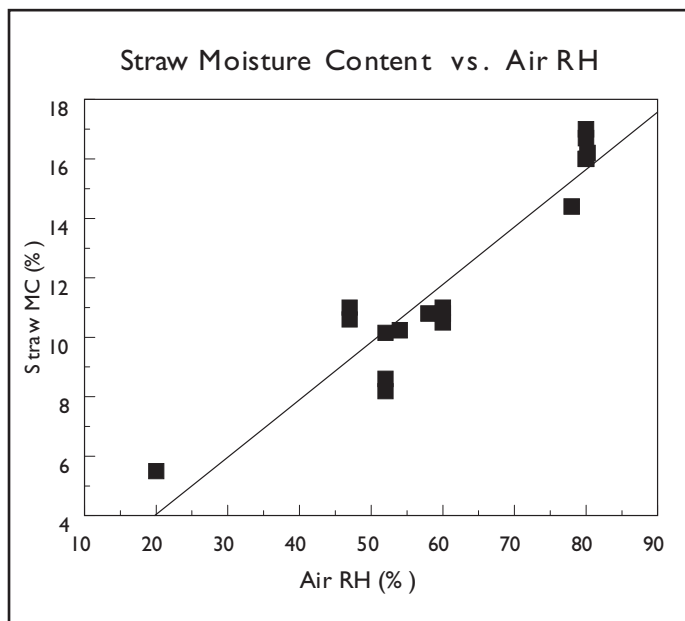
The September readings were generally lower than those at midsummer, at around 11 per cent. These wood moisture contents in Nova Scotia are roughly the same as the air relative humidities as measured in Alberta. See the graph below for a conversion.

The Nova Scotia results showed similar trends. Researcher Shawna Henderson monitored the Nova Scotia houses using wood blocks and wood moisture meters. All readings, for the middle of bale walls, averaged 10 per cent wood moisture content in May and 12 per cent in July, with a few excursions above 15 per cent.
